# **Effect of Fuel Injector Deposit on Spray Characteristics, Gaseous Emissions and Particulate Matter in a Gasoline Direct Injection Engine**

Changzhao Jiang<sup>1</sup>, Hongming Xu<sup>1,\*</sup>, Dhananjay Srivastava<sup>1</sup>, Xiao Ma<sup>1</sup>, Karl Dearn<sup>1</sup>, Roger Cracknell<sup>2</sup>, Jens Krueger-Venus<sup>3</sup>

## **Abstract**

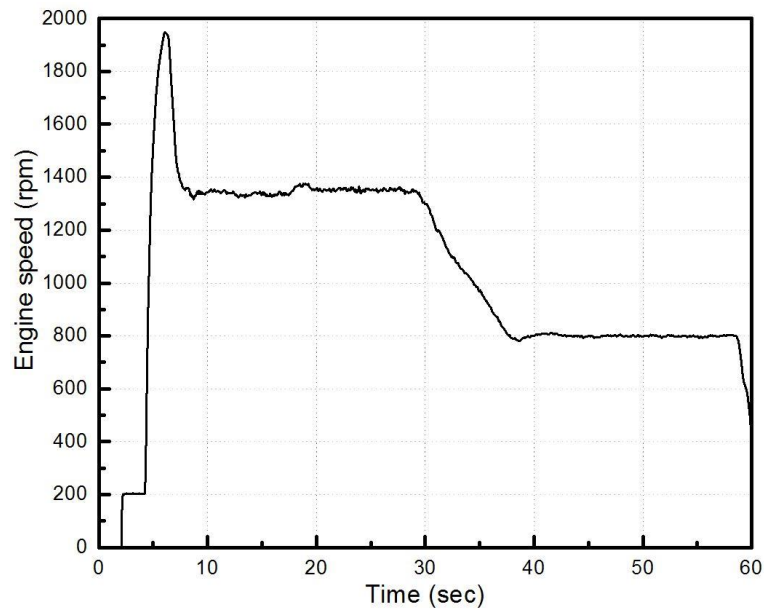
Figure 1: Engine speed versus time for cold start running

The condition of the injector prior to installation in the engine was called the “clean injector” state. The “clean injector” was installed on the spray rig to measure its flow rate and spray penetration lengths of all jets. This created the reference for the spray characterization tests. The deposit accumulation tests were carried out on a dynamometer mounted test engine (see engine specifications in Table 1). Eight “clean injectors” were marked and installed on the engine. The deposit accumulation tests consisted of 6 cold starts (at approximately 20 °C) followed by steady state engine operation for 30 hours. The ECU controlled cold start running process was shown in Figure 1. The whole process lasted for approximated 60 seconds. In the first 9 seconds, the engine speed overshot and stabilized at 1400 rpm for 20 seconds. After that, the engine speed reduced to 800 rpm in 10 seconds. The speed then stayed at 800 rpm (idle mode) until the engine shut down at the end of the 60-second running. The 30-hour steady state running was conducted at an engine speed of 2000 rpm, a load of 5 bar BMEP and at 150bar fuel injection pressure. These operation conditions were chosen because Xu *et al.* [14] summarized in their review that most researchers used low engine speeds (1500-2000 rpm) and medium engine loads (maximum load for engine used in this study was 10 bar) in order to form deposit quickly on the injector tip. During the 30 hours of running, the lambda of the engine was kept at 1 and the fully warmed up coolant temperature was 95°C. The injection pulse width was monitored (engine speed and load were maintained) for the whole running process. It

increased and then stabilized at the end of the 30 hours test. After stabilization, it was considered that the injectors had reached a run-in condition where deposit formation and removal rates were in equilibrium, according to the injector plugging kinetic model proposed by Aradi *et al.* [22]. The injection duration increased while maintaining a constant fuel injection quantity due to a reduction in effective flow rate through the fuel injectors. A representative injector was then taken out of the engine and the flow rate and the spray penetration length measurement were carried out on the same injector after the engine operation (considered as a “fouled injector” state). Comparisons between the “clean injector” and the “fouled injector” were made and the effects of the injector deposit were analysed.

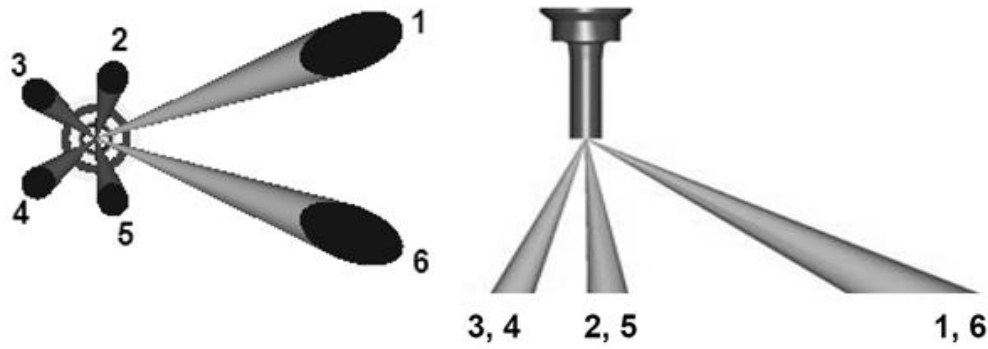
The injector used in this study is a 6-hole GDI injector. The layout of the spray jets is shown in Figure 2. It had 3 sets of symmetric jets named jet 1 to jet 6. The symmetric jets had the same spray inclination angle relative to the injector axis.

Figure 2: Nomenclature of the spray jets.

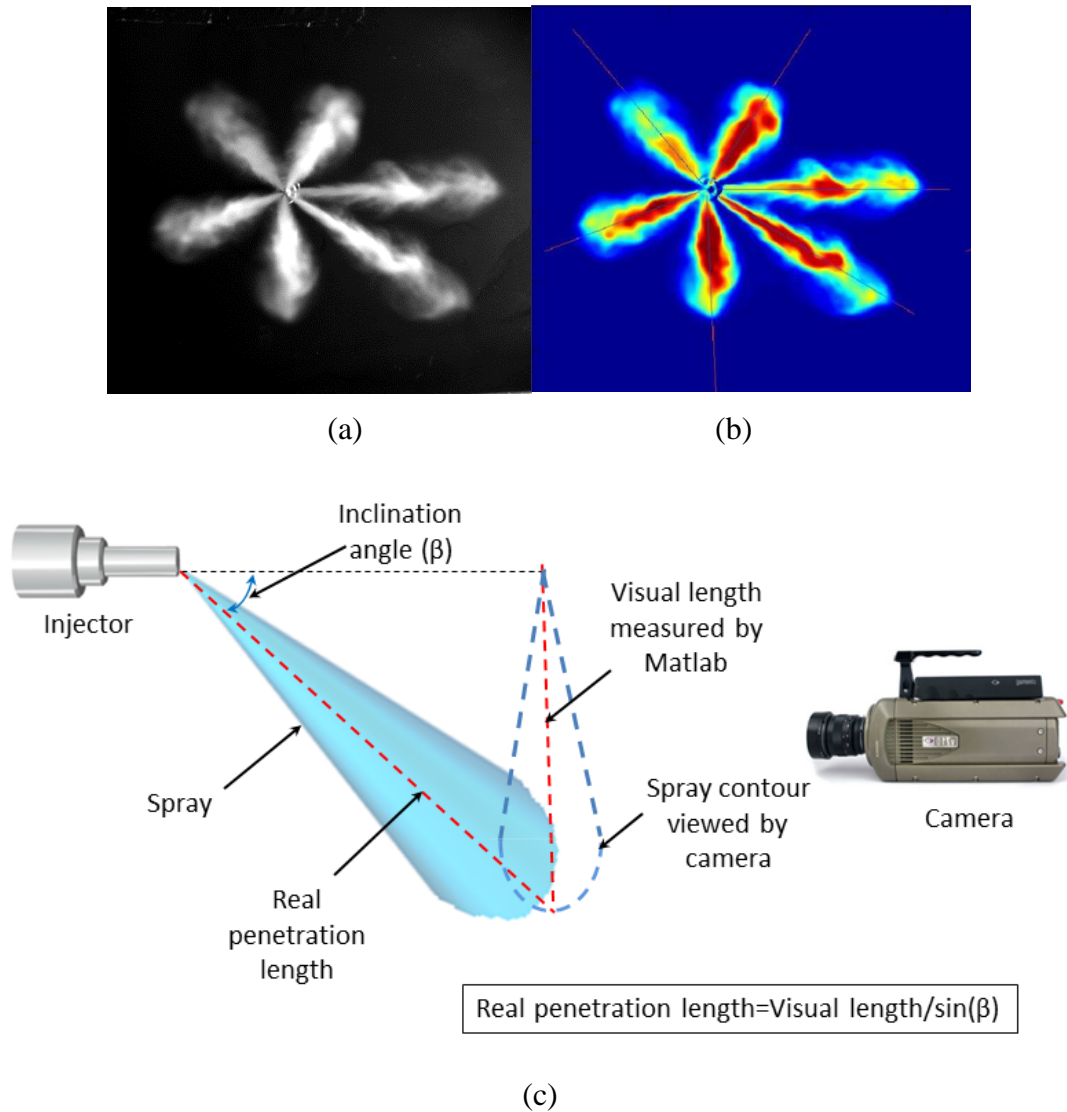
The spray penetration length was the essential parameter describing the macroscopic characteristics of the spray. In order to measure the spray penetration length, MATLAB code was created to process the images recorded by the high speed camera. Figure 3 a and b show the original image and the MATLAB processed image used for analysis. The MATLAB code drew reference lines along the spray axes and measured penetration lengths of the 6 jets. Thus, the visual penetration length was measured by identifying the grayscale change along this reference line. The actual penetration length could then be calculated according to the inclination angle of the spray, as shown in Figure 3 c. The pixel/length ratio was measured and calculated before the

test so that the penetration length could be transferred from pixel to physical length. In order to avoid shot-to-shot variation, 10 groups of images were recorded for 10 injections at each test point. The averaged penetration length was used in further analysis.

Figure 3: High speed imaging data processing (a) original image (b) processed image (c) transformation from visual length from real length.

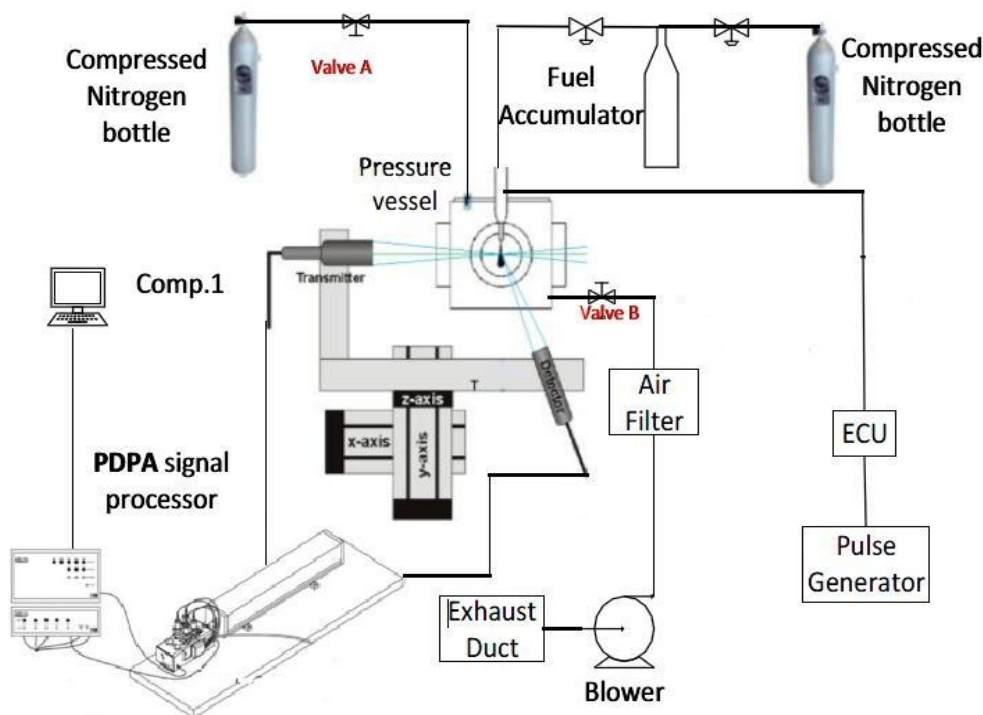
The droplet sizes of different spray jets were measured using a PDPA system. The schematic of the PDPA system used in this work is shown in Figure 4. The entire PDPA system, including the transmitting optics and the detectors, were fixed on a 3D

traverse system allowing the measuring point to moved 3 dimensionally within an accuracy of 0.01 mm. The droplet sizes of the ‘clean injector’ and the ‘fouled injector’ were compared and the effects were analysed.

Figure 4: PDPA system in this test.

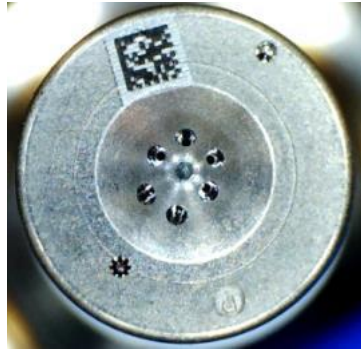
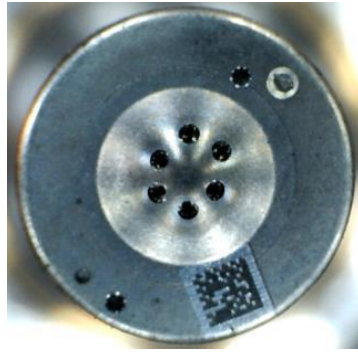
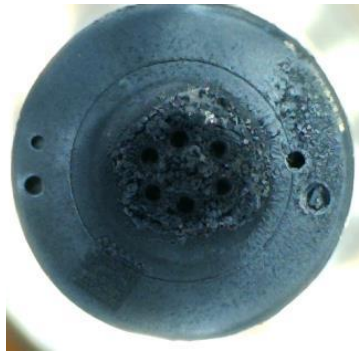
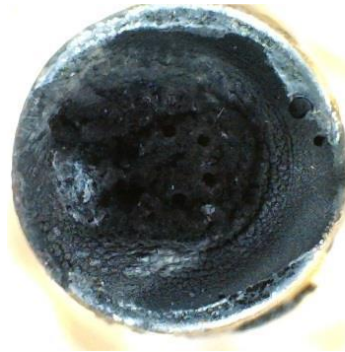
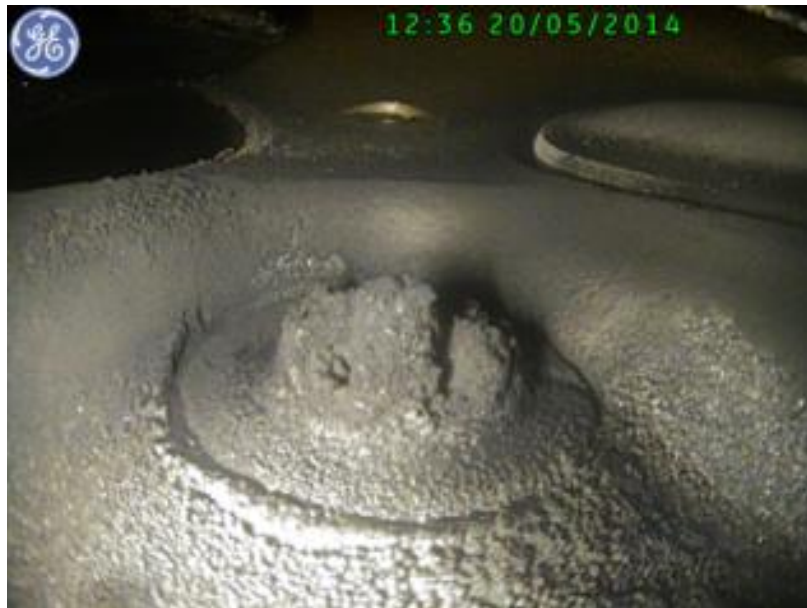
Figure 5 a-d shows images of the external part of the injector after being removed from the engine at different stages of the deposit accumulation. A boroscope was used to visualize the ‘in-situ’ external status of the injector (i.e. in the combustion chamber) after the deposit accumulation test (Figure 5 e). In the case of the clean injector (Figure 5 a), the tip is clean and the injector holes are fully visible. After 2 cold starts some black deposits were formed on the injector tip, while after 6 cold starts a

noticeably larger area of the injector tip surface was covered by deposits, showing the effect of the cold start in the creation of external deposits. Figure 5 d and Figure 5 e show the injector after the 6 cold starts and 30 hours of deposit accumulation test. The injector tip was totally covered by deposits created mainly during the steady-state engine operation. Visually the sizes of the holes were much smaller compared to its clean status, as shown in Figure 5 a.

Figure 5: Deposit formation process on the injector tip (a) clean injector, (b) injector after 2 cold starts, (c) injector after 6 cold starts, (d) injector after 30 hours deposit accumulation tests, (e) 'in-situ' injector status

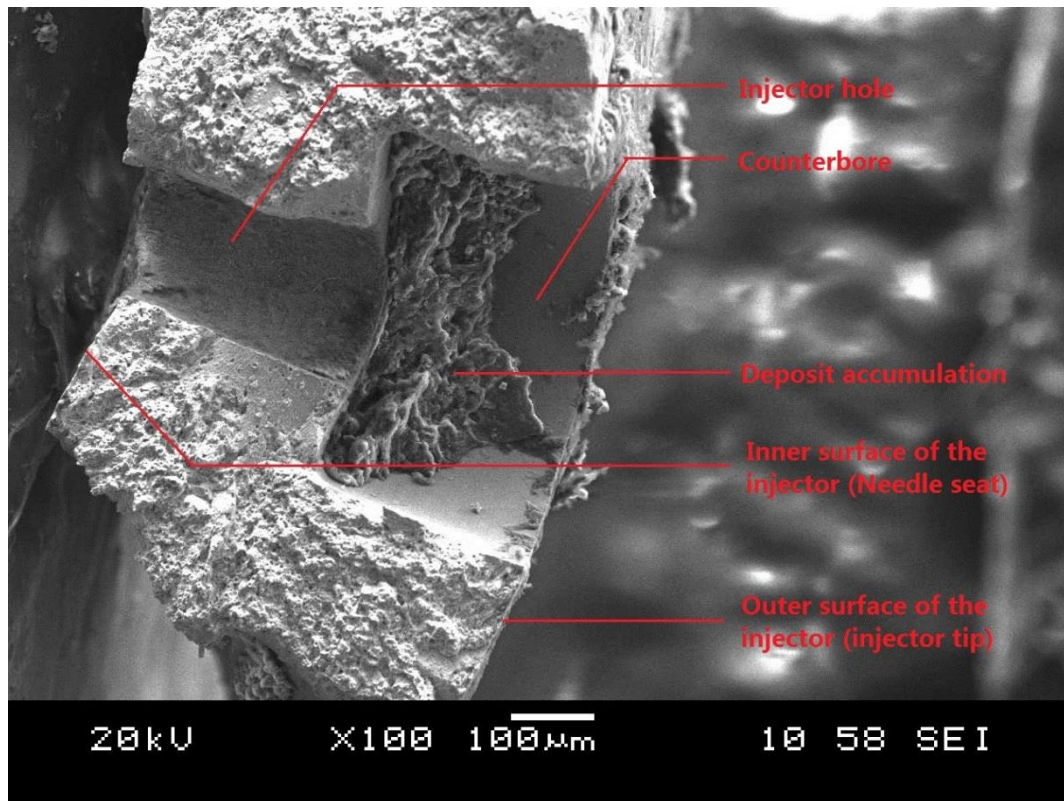
In order to gain a deeper understanding of the deposit accumulation, this injector was split and magnified scan electron microscope (SEM) images (Figure 6) were taken to identify the location of the deposit accumulation inside the nozzle. It can be seen that on the internal parts, the needle seat and the injector hole, very little deposit could be seen. However, on the external counterbore, large quantities of deposit were present. Combining the observation derived from ‘in-situ’ and ‘off-site’ deposit visualization techniques, it could be concluded that at this stage of the injector fouling, the deposit mainly accumulated on the counterbore and in the outer parts of the injector holes (injector tip). In the other work conducted by the authors’ group [5], detailed Scanning Electron Microscopy with Energy Dispersive X-Ray Spectroscopy (SEM-EDS) was conducted in order to understand the components of injector deposits. The EDS analysis showed that the deposits in different locations of the injector consist of different levels of typical fuel and lubricant elements, such as C, O, Na, Mg, Si, P, S, K, Ca, Mg and Zn. Four dominating elements (C, S, Ca and O) were identified for the injector.

Figure 6: SEM image for deposit formation in the injector nozzle

1. The deposit accumulation process created deposits not only on the injector tip but also inside the injector nozzle. Significant amount of deposits were observed on the counterbore while barely no deposit was observed on the deeper part of the nozzle (i.e. nozzle hole).

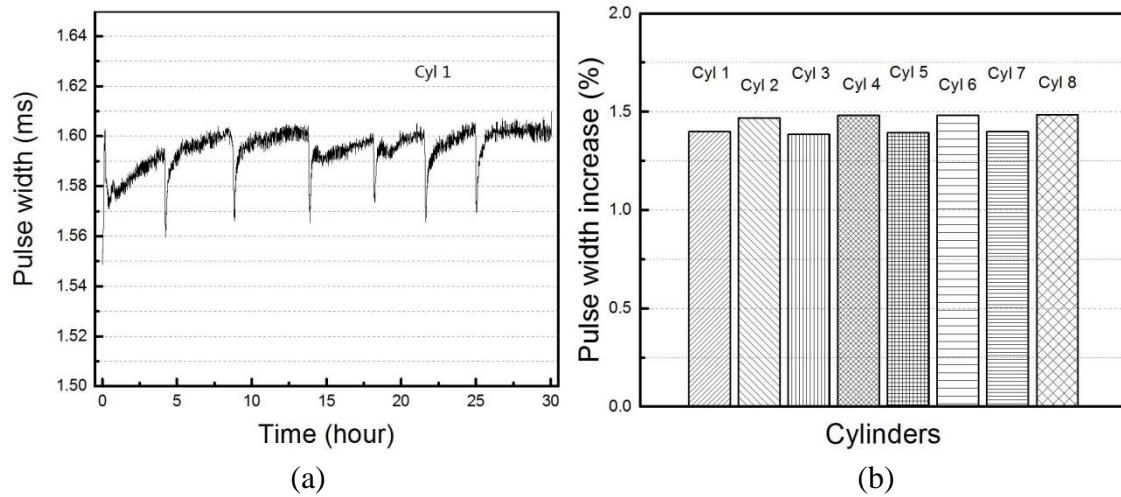
Figure 7 a shows the measured injection pulse width for cylinder 1 of the engine during the deposit accumulation steady state operation (2000 rpm, 5 bar BMEP and 150 bar injection pressure). It can be seen that the injection duration slowly increased on each day of the test (over a total of 7 days for the 30 hour test). This increase could be due to either a loss in fuel efficiency (a higher quantity of fuel therefore being needed to maintain the same engine performance) or a reduction of the injector flow rate because of the accumulation of deposits which would require compensating with a longer injection duration to deliver the same quantity of fuel, or the combination of both effects. In the last 4 hours of this 30-hour test (day 7), the pulse width stabilized at around 1.60 ms. It is considered that the injectors had reached a run-in condition where deposit formation and removal rates were in equilibrium. Figure 7 b presents

the percentage of pulse width increase in all 8 cylinders. The pulse widths of the injectors in all 8 cylinders increased by a similar amount, between 1.4% and 1.5%, meaning that they all had a similar level of fouling. Thus, it is reasonable to analyse only one representative injector. In later parts of this paper, optical diagnostics, including flow rate measurement, high speed spray imaging and PDPA measurement, were conducted on the injector from engine cylinder 1.

Figure 7: Pulse width changes (a) Pulse width of injector placed in cylinder 1 over 30-hour test (b) Percentage of pulse width increase in 8 cylinders after 30-hour test.

In order to confirm that the increase of injection duration (shown in Figure 7) was caused by a reduction of the injector flow rate, the “off-site” (i.e. an injector flow test rig) injector (cylinder 1 injector) flow rate under different injection pressures and pulse widths for a constant number of injection (500) were measured using isooctane. Figure 8 shows the injected mass for the clean status (before deposit accumulation tests) and the fouled status (after deposit accumulation test) of this injector for 500 pulses at a pulse width of 1.5 ms. Reduction of the flow rate was observed at three injection pressures because of the presence of deposits on the chosen injector created during the deposit accumulation process. When the injection pressure is low (i.e. 50 bar) or injection pulse width is short (i.e. 0.38 ms), the flow rate loss becomes more obvious (see Table 3). Overall, the flow rate for the injector is reduced after the deposit accumulation test by 2-8% depending on pulse width setting and injection pressure.

The engine brake specific fuel consumption (BSFC) is presented in Figure 13. Irrespective of the injector fuel flow rate loss observed from Figure 7, Figure 8 and Table 3, the engine fuel consumption was not significantly changed during the 30-hour running. Figure 14 shows the rate of variation of engine output gaseous emissions during the steady state deposit (after cold starts) accumulation experimental test, while Figure 15 compares the evaluation of the engine out gaseous emissions with the clean and fouled injectors at different injection pressures. It can be seen that the variation rate of CO<sub>2</sub> and CO emissions was almost negligible (around 1-1.5% increase with respect to the start of the test). These variations, while potentially being considered statistically negligible, were also observed in Figure 15 a and Figure 15 b. Interestingly, the NO<sub>x</sub> emissions seemed to slightly decrease with the steady state engine operation (especially from 8 to 25 hours of operation, Figure 14). Figure 15 d also confirms a slight decrease in NO<sub>x</sub> emissions at injection pressure of 50 and 100 bar (around 2%).

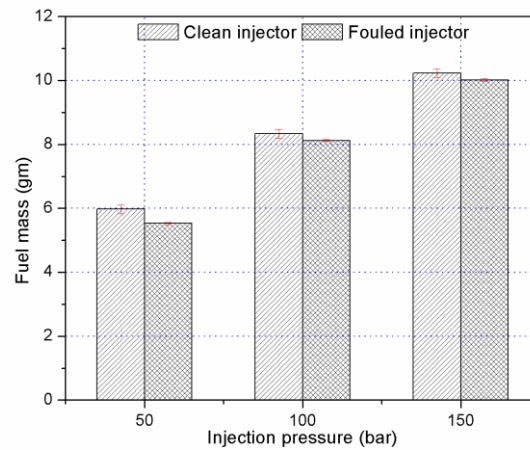
Figure 8: Flow rate for the injector tested on the spray rig under different injection pressures (1.5 ms pulse width, 500 injections)

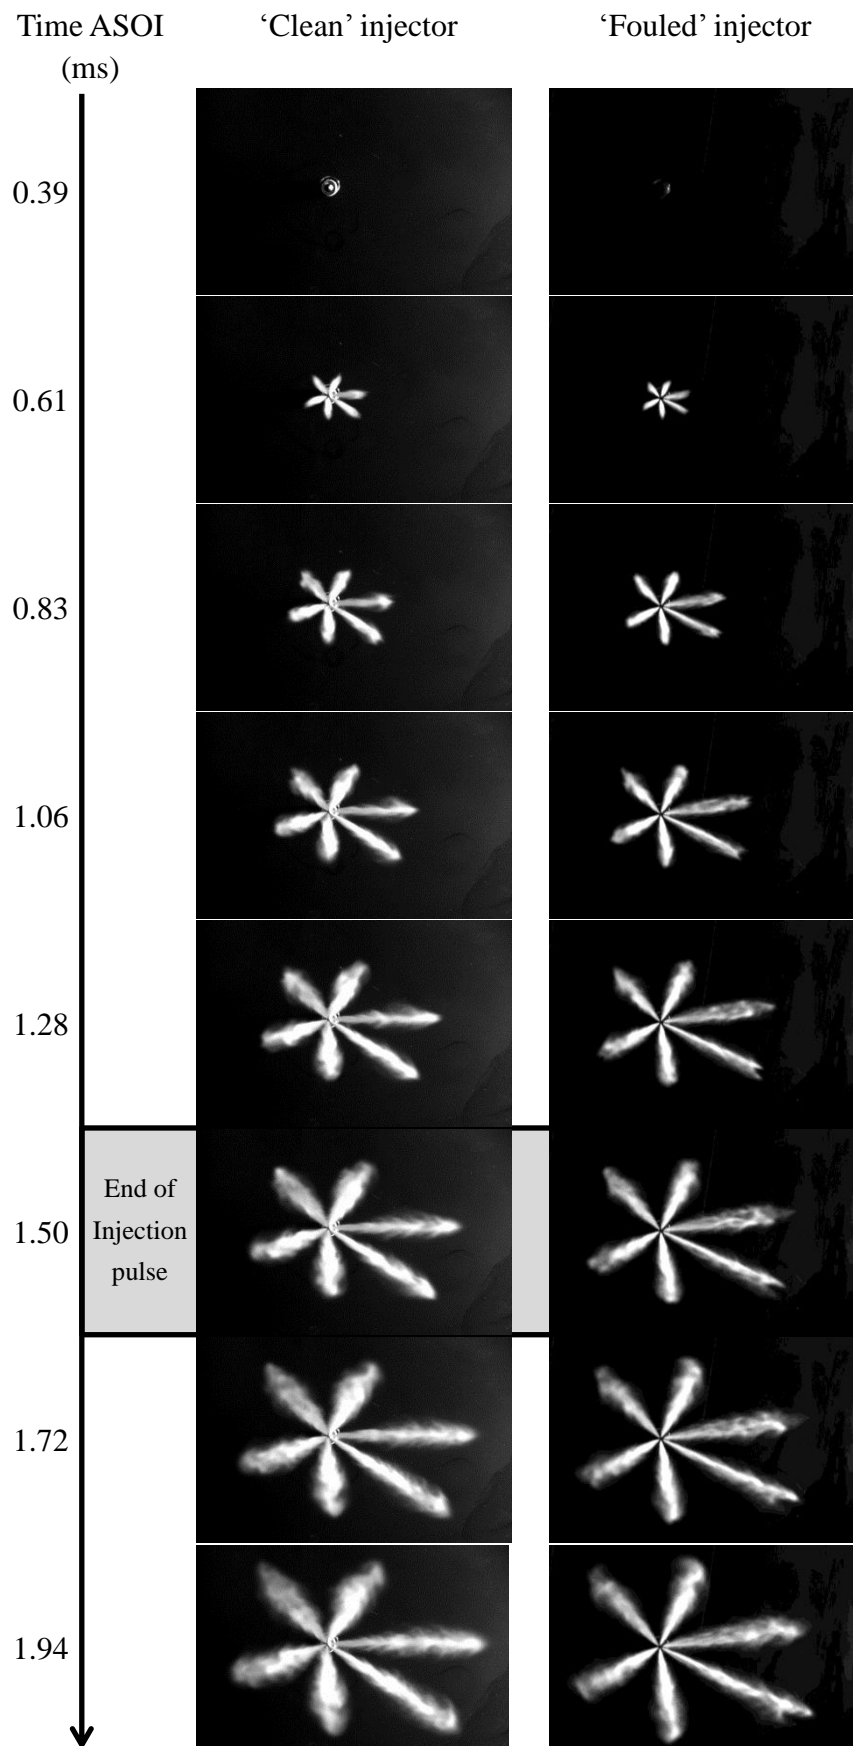
Figure 9 shows the chronological images of the spray from 0.39 ms after the start of injection (ASOI) to 1.94 ms ASOI for the 6 jets of the injector previously analysed. On the first images, there is no spray due to the injection delay, although, with the evolution of the jets, some clear differences in the spray pattern could be observed between the ‘clean’ and the ‘fouled’ injectors. In comparison to the ‘clean’ injector, the spray cone angle of the ‘fouled’ injector is smaller due to deposit accumulation on the injector tip. This phenomenon affects the in-cylinder mixture formation and will eventually affect the gaseous emissions and PM emissions.

Another visual difference observed for the ‘fouled’ injector was the presence of jets with divergent tips (i.e. for the symmetric jets one of the tips is much longer than the other in the late stage of the injection duration). In order to quantify the change of the

Figure 9: Chronological images of the spray at injection pressure of 150 bar and injection pulse width of 1.5 ms.

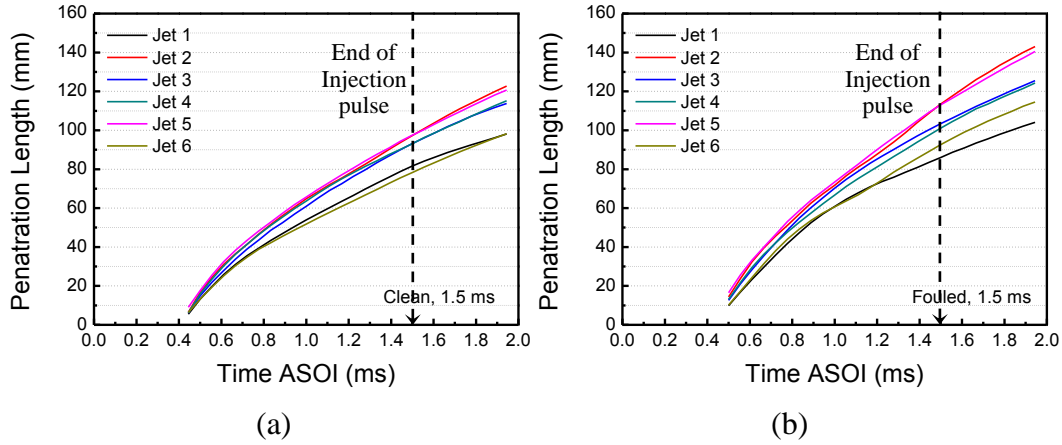
penetration length from jet to jet for the ‘clean’ and ‘fouled’ injectors, statistical analysis of the spray penetration length before and after the deposit accumulation tests have been carried out (see Figure 7 for 150 bar injection pressure and 1.5ms injection duration). For the ‘clean’ injector, its symmetric jets had nearly the same penetration lengths as shown in Figure 10 a. However, for the ‘fouled’ injector some of the symmetric jets, for example jet 6, has a penetration length longer than jet 1 at the later stage of the injection (Figure 10 b). This comparison also reveals that the penetration lengths of all the jets increased after the deposit accumulation tests. Detailed comparison of the percentage of the penetration length increase of the 6 jets at different injector status and injection pulse widths is given in Table 4. Generally, the increment of the penetration length after the deposit accumulation test is around 10-15%, but the magnitude (10-20%) and jet to jet variability increased for the shortest injection pulse width. Overall the penetration length percentage increase of jet 6 was the largest, while the percentage increase of jets 1 and 4 were the shortest. This confirmed a variation of the injector tip deposit build-up on different nozzle holes.

Figure 10: Penetration lengths of 6 jets at an injection duration of 1.5ms (a) Clean injector (b) Fouled injector.

From Figure 10, it can be seen that when the injector is clean the symmetric jets had the same penetration length. However, after the injector was fouled, jet 6 had a much longer penetration length than jet 1, while the differences for the other two sets of symmetric jets were smaller. Therefore, jet 1 and jet 6 were chosen for further droplet sizes analysis after deposit accumulation tests and were compared with respect the droplet sizes corresponding to the clean injector. For the other two pairs of symmetric jets, only one jet in each pair (jet 2 and jet 3) was chosen for further analysis.

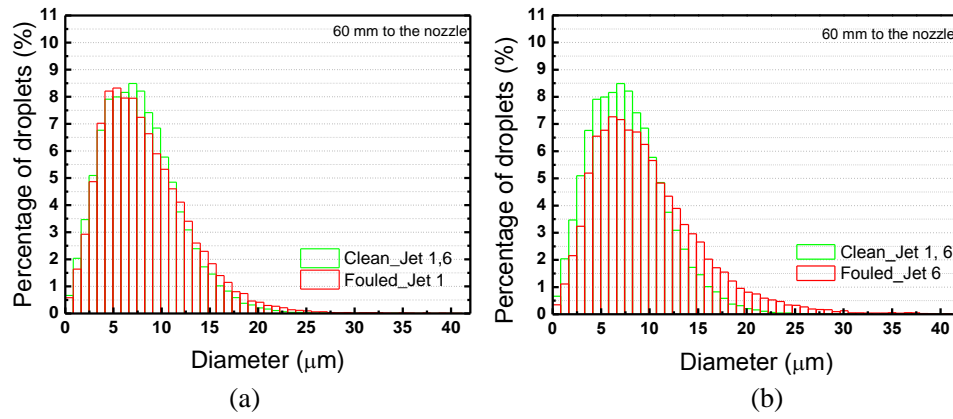
In order to understand the impacts of deposits on microscopic characteristics of the spray, PDPA measurements were conducted for the chosen jets at a distance of 60 mm from the injector tip, at an injection pressure of 150 bar and injection pulse width of 1.5 ms under atmospheric conditions. Since the experiments were carried out at such a

long distance towards the injector tip, the spray was suitably sparse for PDPA measurements to be made with very high validation rates, between 85% and 92% for all the test points in this paper. Histograms of the clean and fouled status of jet 1 and 6 sprays are compared in Figure 11. It can be seen that the droplet size distribution behaves similarly to a log-normal distribution which indicate that a statistically significantly number of droplets had been analysed. This figure gives insights into the effects of accumulated deposits on the probability distribution of droplets diameters. For both jet 1 (Figure 11 a) and jet 6 (Figure 11 b), it could be seen that the numbers of large droplets (larger than 12  $\mu\text{m}$ ) significantly increased after the fouling tests. The average droplet size (Sauter mean diameter, SMD) at different spatial distances to the nozzle tip was calculated from the droplet size distributions. For the 'clean' injector (Figure 12 a), the average droplet sizes of all the jets were quite similar. However, after the deposit accumulation tests, the droplet sizes of the jet 1 and 6 were significantly different and larger than in the case of the clean injector. Table 5 summarizes the percentage of SMD value increased after the deposit accumulation test for jets 1 and 6 at three different injection pulses. Jet 6 has the largest droplet size variation (around 30%) in accordance with the largest variation in penetration length which suggests either a larger deposit built-up in the hole number 6 or a higher effect of the presence of deposits in the hole number 6 on spray morphology.

Figure 11: Histogram of the droplets at 60 mm distance to the nozzle for clean injector and fouled injector (a) Clean injector Jet 1,6 compared to Jet 1 (b) Clean injector Jet 1,6 compared to Jet 6

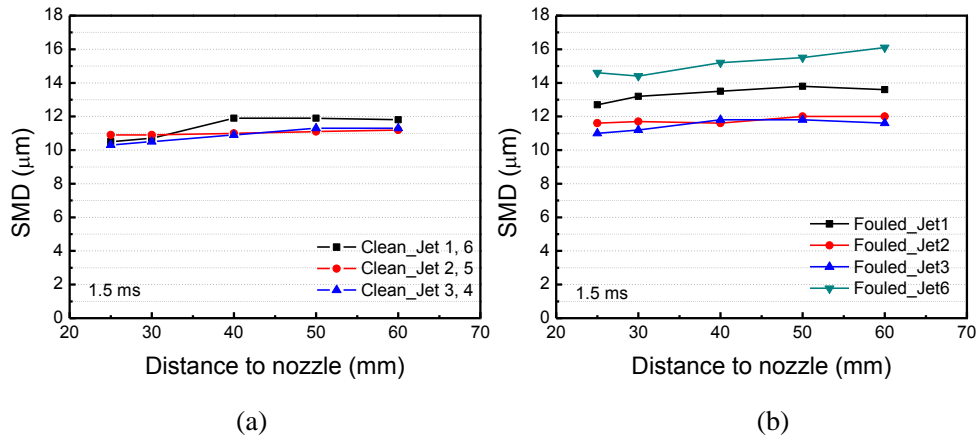
Figure 12: SMD value of the clean and fouled status (a) Clean injector (b) Fouled injector

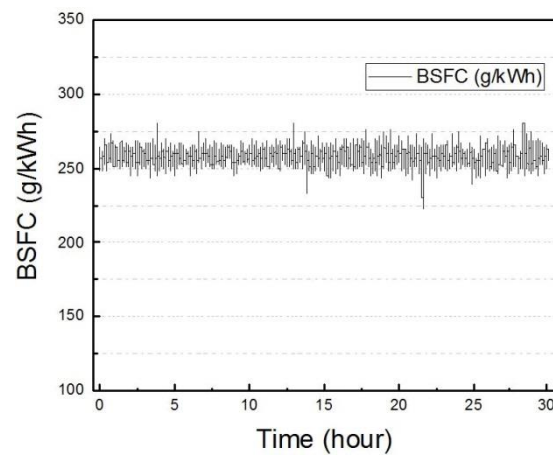
Figure 13: Engine break specific fuel consumption (BSFC) over 30-hour running

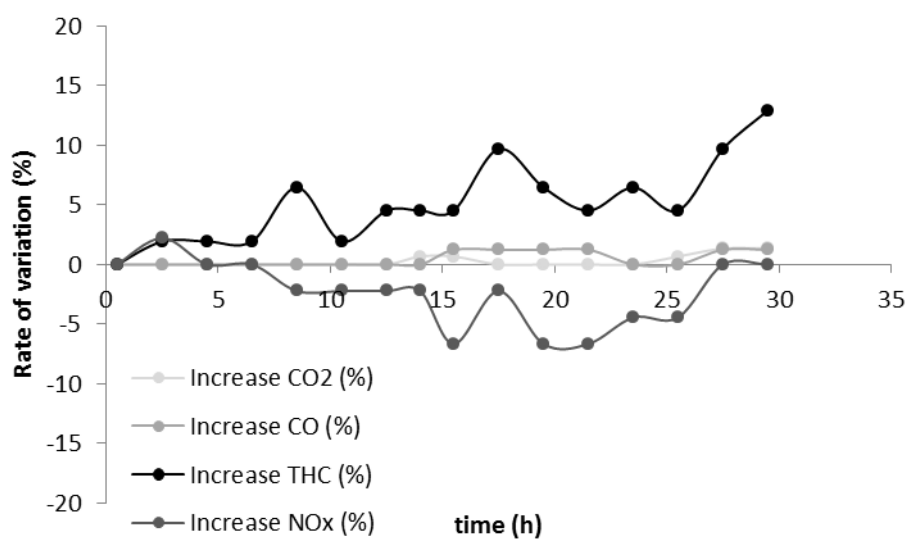
The most statistically significant effect of the deposit formation on engine output gaseous emissions occurs for unburnt HC. It can be clearly seen that HC emissions increase with the steady state engine operation and this is also confirmed when the deposit effect is evaluated at different injection pressures. Figure 15 c also shows that the decrease of the injection pressure leads to an increase of the HC emissions. It is believed that this increase is due to a worse atomization of the spray at lower injection pressures being especially noticeable for the 'fouled' injectors. The large influence of

Figure 14: Variation rate of gaseous emissions during the deposit accumulation test (after cold starts)

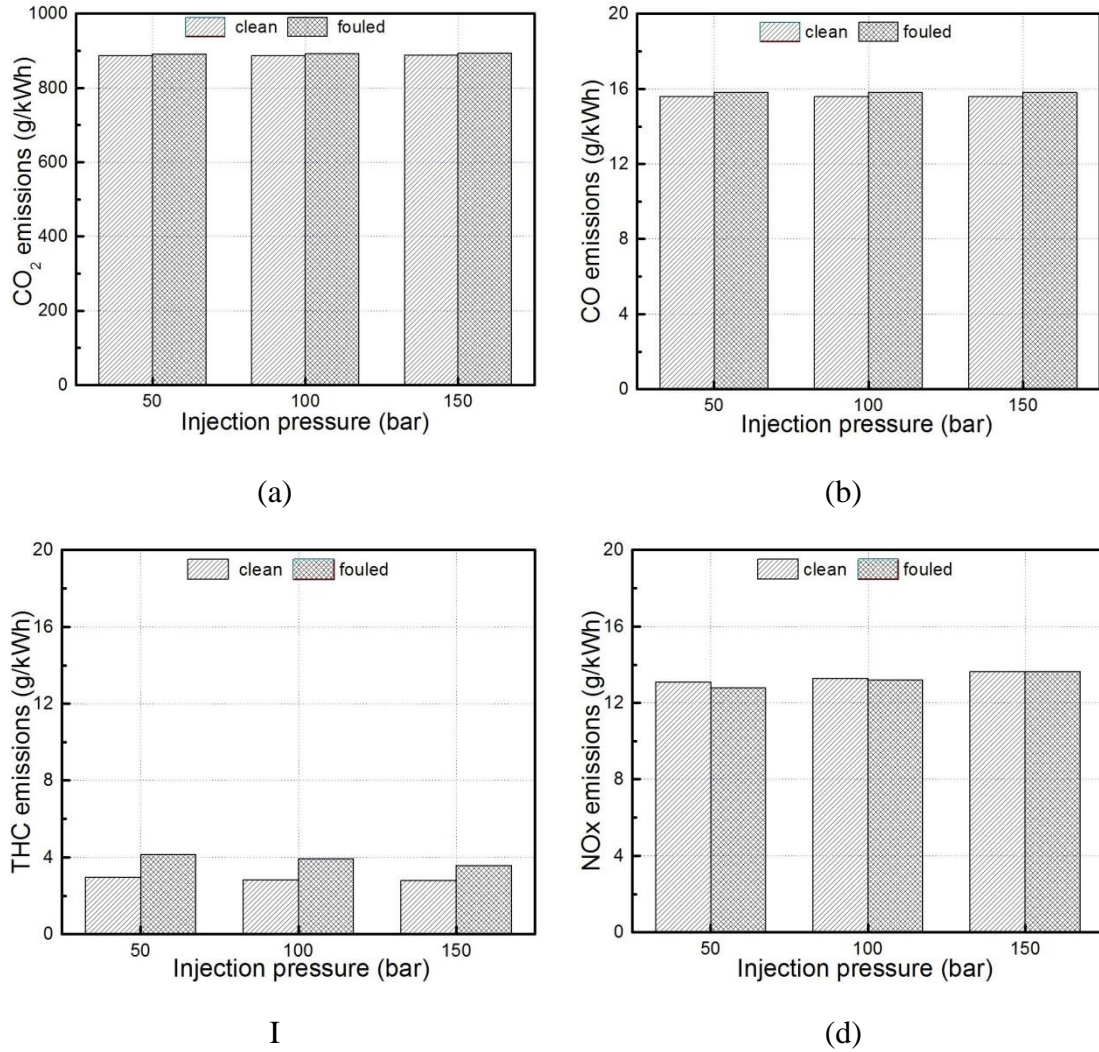
injector pressure in injector flow rate and unburnt hydrocarbons for the fouled injectors suggests the major contribution of injector hole deposits to the increase in unburnt hydrocarbon emissions was in-cylinder mixture deterioration rather than the presence of injector tip deposits which should not be largely influenced by the injector pressure. Therefore, it is concluded that the increase of the unburnt hydrocarbon emissions was due to i) deposits in the injector hole and ii) injector tip deposits (in direct contact with the combustion chamber and outer of the injector hole).

Figure 15: Gaseous emissions of the engine before and after the deposit accumulation test (a) CO<sub>2</sub> (b) CO (c) HC (d) NOx

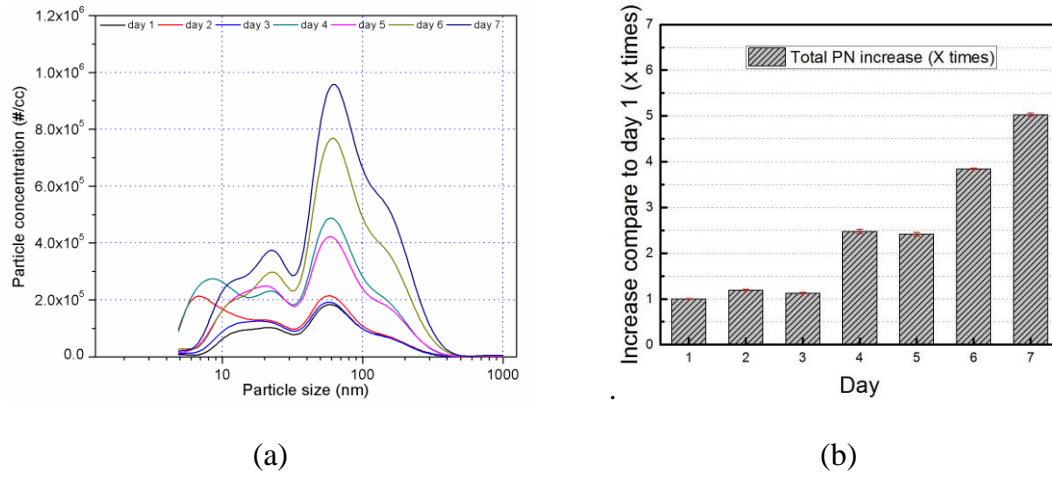
The engine-out particulate size distributions in the 30 hours of deposit accumulation tests are shown in Figure 16 a. It can be seen as bimodal (nucleation and accumulation) particulate size distributions were obtained. Nucleation mode is mainly composed of droplets of hydrocarbons, while the accumulation mode is composed by both soot and adsorbed/condensed hydrocarbons on the soot agglomerates [16]. During testing, the total particle number increased, as shown in Figure 16 b. At the end of the deposit accumulation tests, the ‘fouled’ injectors produce PM emissions around 4-5 times higher than for the ‘clean’ injectors for the standard ECU settings injection pressure.

The increase in particulate emissions occurred both for the nucleation mode (according to the increase in the unburnt hydrocarbon emissions) and more dramatically for the accumulation mode. The high concentration of particulate emissions in the accumulation mode for coked injector indicated high soot formation, which was a result of diffusive combustion. Diffusive combustion could occur in the cylinder if (1) there is spray-wall impingement (caused by longer penetration length); (2) there is residual fuel absorbed by deposits formed outside the injector tip (as shown in Figure 5 e) after injection (3) there are very rich areas or big fuel drops in the cylinder after injection. Fouled injectors could potentially deteriorate PN emissions from all three aspects thus higher level of particulate emissions was seen in the accumulation mode.

Figure 16: PM emissions of the engine during the deposit accumulation test (a) particulate size distribution (b) total PN increase.

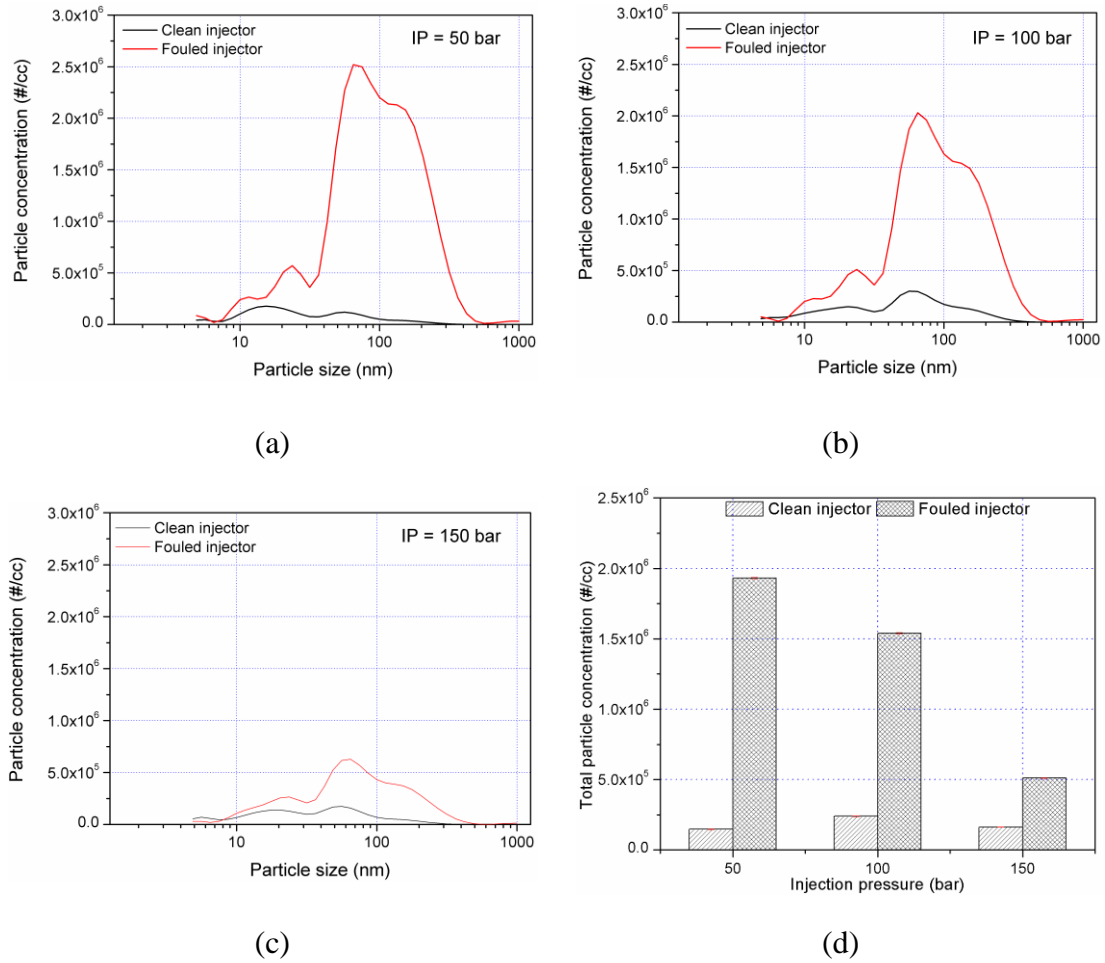
Figure 17 shows the impact of different injection pressures on PM emissions. The effect of injection pressure on particulate size distributions was small when the injectors were 'clean' (no statistically significant effect on accumulation mode but an increase in nucleation mode according to the increase in unburnt hydrocarbon emissions), as shown in Figure 17 a b and c. However, in the case of the 'fouled' injectors, a decrease in the injection pressure increased the nucleation mode and dramatically increased the accumulation mode. As in the case of unburnt hydrocarbon emissions, the effect of injection pressure on particulate matter formation for the 'fouled' injectors identified the large contribution of counterbore deposits to particulate matter through the modification of the spray in addition to the contribution of injector tip deposits which promote diffusive combustion and the formation of

particulate matter (mainly in the accumulation mode). The partial contributions of i) internal deposits and ii) tip deposits will vary depending on the engine operating conditions. There were some cases (defined by injection timing, injection pressure, fuel quantity, etc.) in which the modification of fuel spray characteristics due to the accumulation of internal deposits would not be critical for in-cylinder mixture and emissions formation and the effect of injector tip deposits would be more important on particulate formation (e.g. diffusive combustion of the fuel attached on the injector tip deposit).

Figure 17: PM emissions of the engine before and after the deposit accumulation test for different injection pressure (a) 50bar (b) 100 bar (c) 150 bar (d) total PN
